Borescope Inspection Report

Engine ID: #1

Engine Model: MTU 20V4000 L64

Inspection date: 7 November 2023

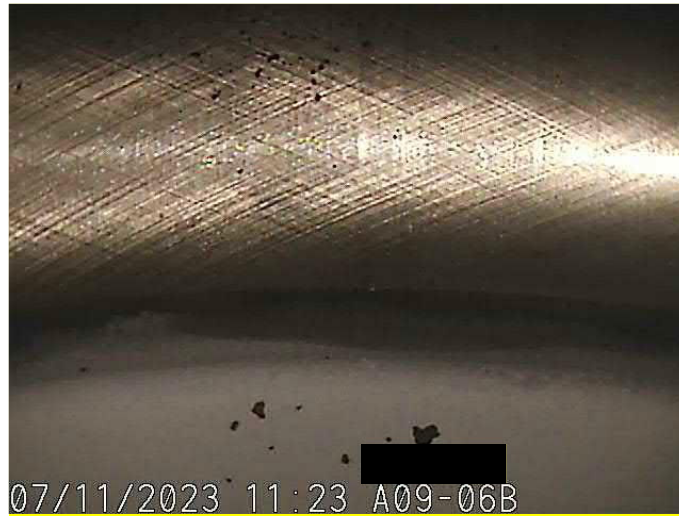
During the inspection a number of specific observations were made. In A9 black deposits were noted, as shown below. Similar deposits were also seen in B7.

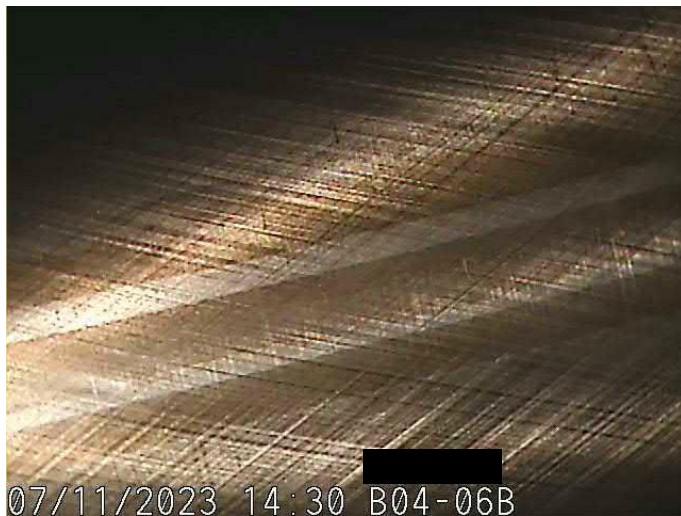
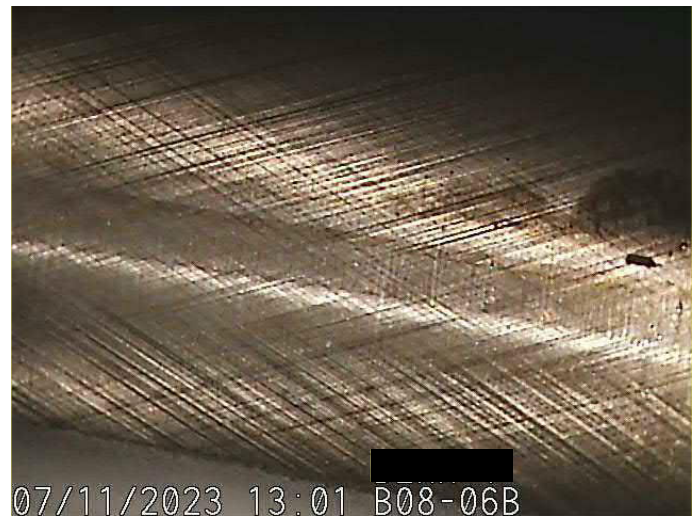
In a number of cylinders evidence of a historic water marks were seen, possibly from the engine being stored for an extended period of time and water collected on the piston crown and between the piston ring and liner. Typical photos are shown below. These are shown for completeness and are unlikely to be associated with the engine derating issues.

In most instances the mark is just that.

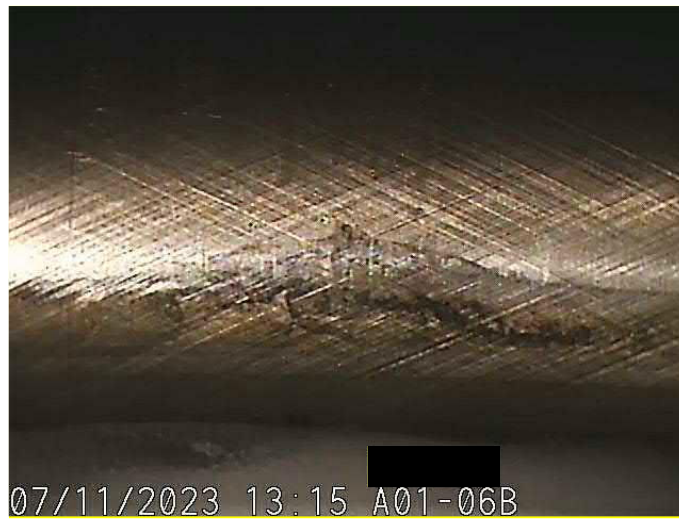
In A1 at the 06:00 bottom location the mark is more unusual.

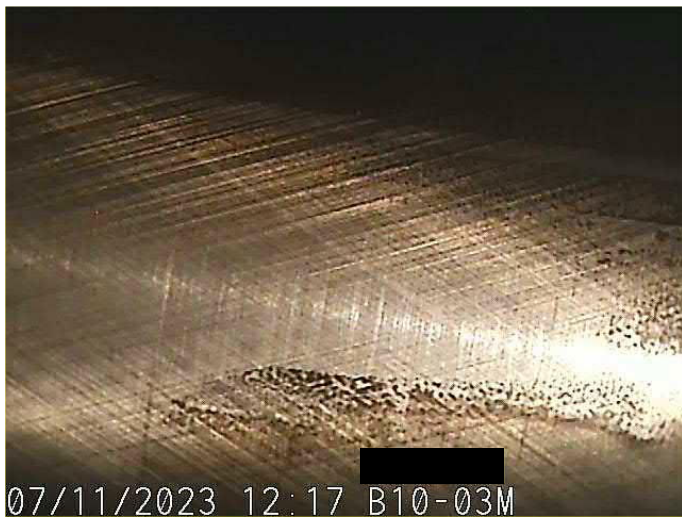
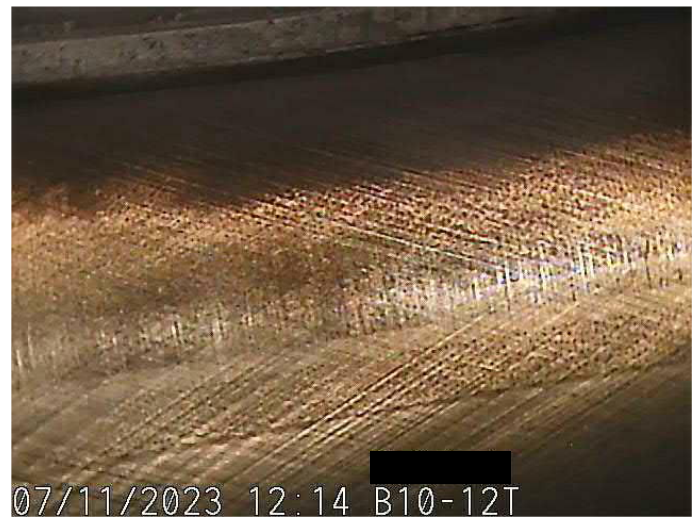
In B10 there is evidence of corrosion pitting, as shown below.

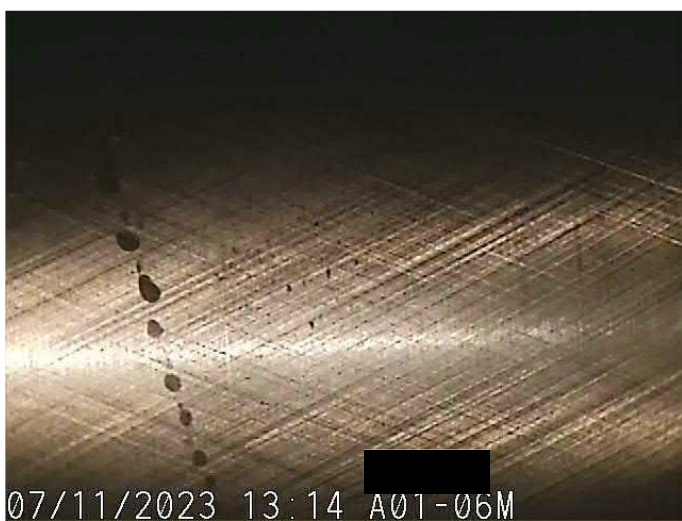
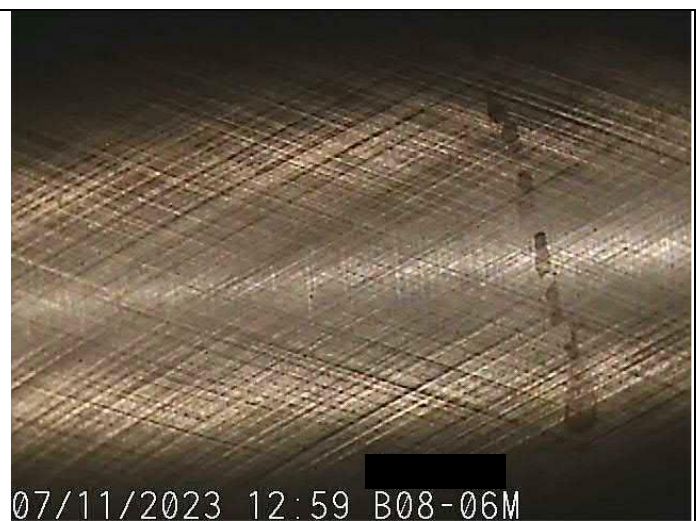
Cylinders A1 and B8, both at the 06:00 mid position, had unusual marks not seen elsewhere, again unlikely to be related to the derating issue.

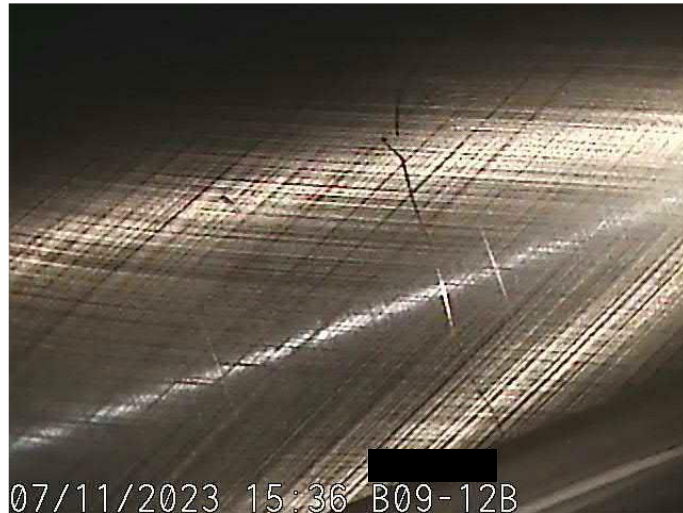
In B9, at the 12:00 bottom position there is a fresh looking mark, possibly some debris has been trapped in the piston ring and has created this score during the barring, hence the non-linear nature of the score as the piston ring has rotated slightly.

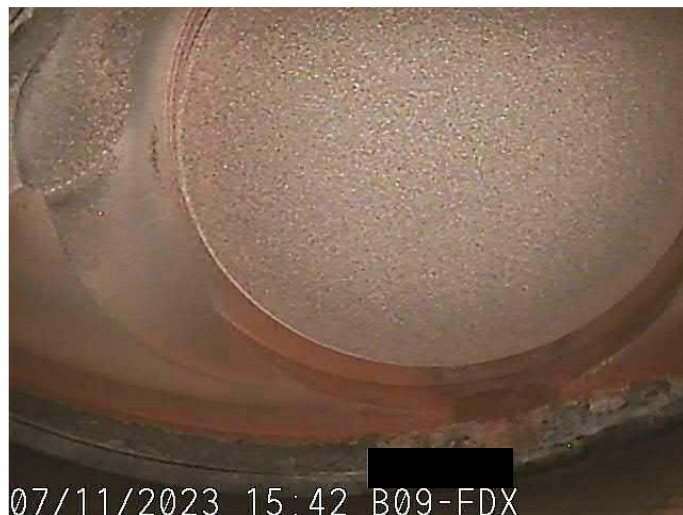
There is evidence of a pinkish tinge on some flame decks typically indicative of coolant contamination. However, there are no indicators of such contamination in the used oil analysis data.

A slight pink discolouration was noted in some cylinders, A2, A5, and B9. This is usually associated with coolant contamination but there are no indicators in the used oil analysis data (up to and including the sample from 4 October 2023, 5843 hours).

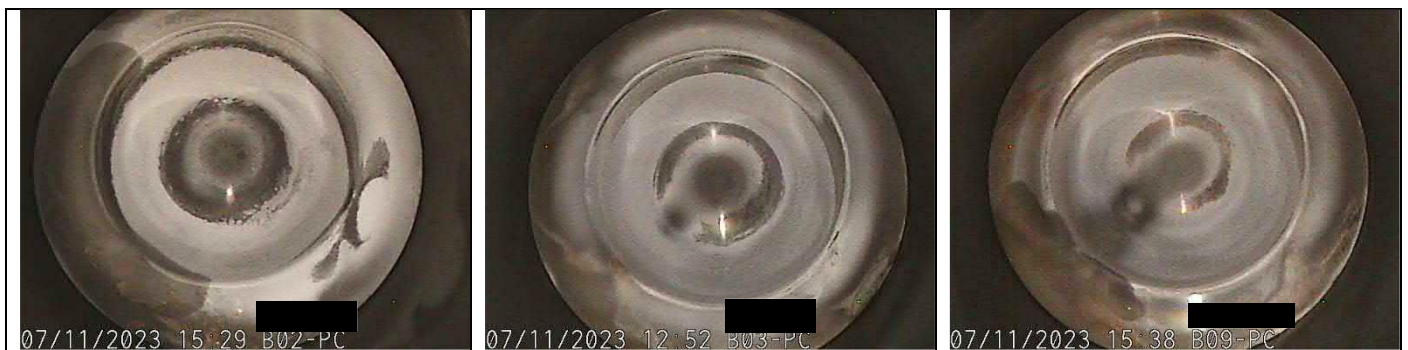
The ash was generally light and even with the exception of B2, B3 and B9 which had patchy ash coverage and exposed areas of piston material.

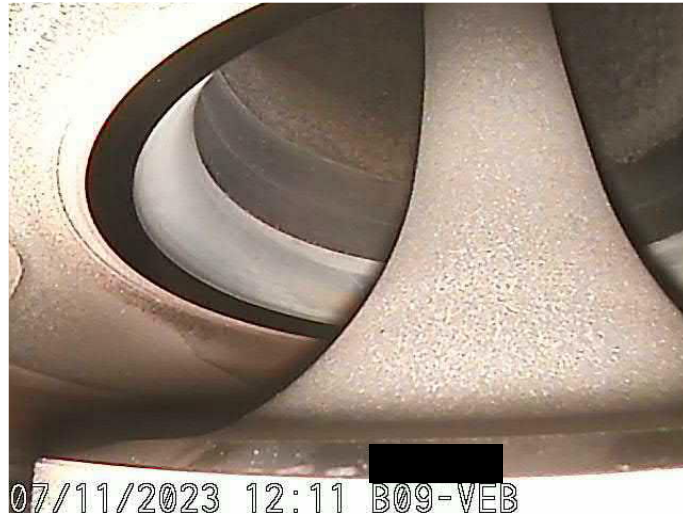
Time constraints limited the number of valves that were inspected and only exhaust valves were seen. Those were similar in condition with light even coating of ash and the seats in good condition.

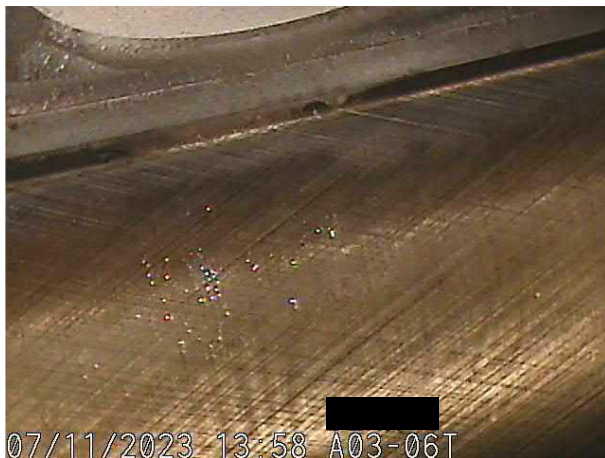
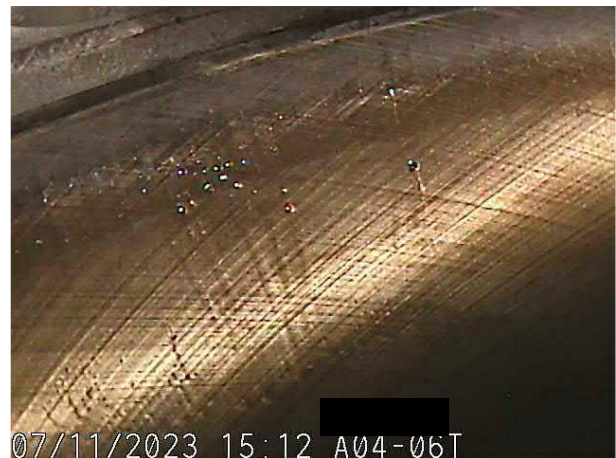
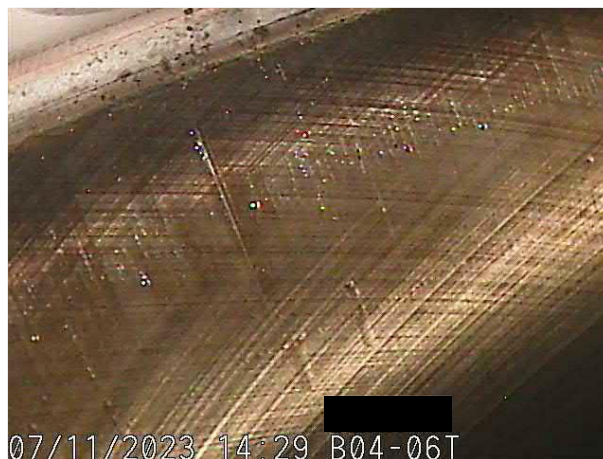
Around half of the cylinders had significant amounts of oil on the liner, and the associated piston crowns were generally darkened from the edges, likely oil contamination. Generally, the flame decks were dry with no evidence of excessive oil contamination coming from the valve guides. This suggests that excessive amounts of oil are contaminating the combustion chamber through the piston rings, though it also has to be remembered, as highlighted in the report, that the heavier contamination was seen in the cylinders inspected after the engine had been barred over more.

Excess oil was noted on a number of liners, some examples of which are shown below. The liners affected in a similar manner were

Barring Cycle	Oily Cylinders
Virtually none	A9
1 st	A1, A10
2 nd	A3, A8
3 rd	A5, B2, B4, B7
4 th	A4, A7, B2, B9

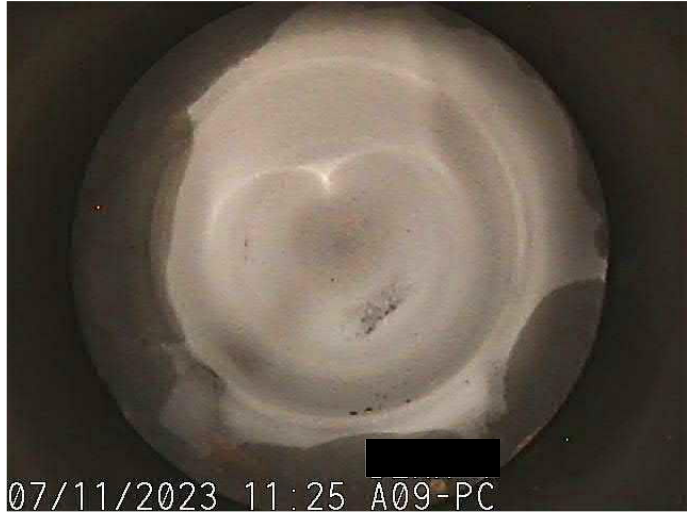
Excess oil was also noted on a number of piston crowns.

It is appreciated that some oil contamination of the liner and piston crown can occur when the engine is barred over to allow the full swept liner area to be inspected. The above photo had almost no engine movement prior to be taken. The order of inspection is shown on page 49.

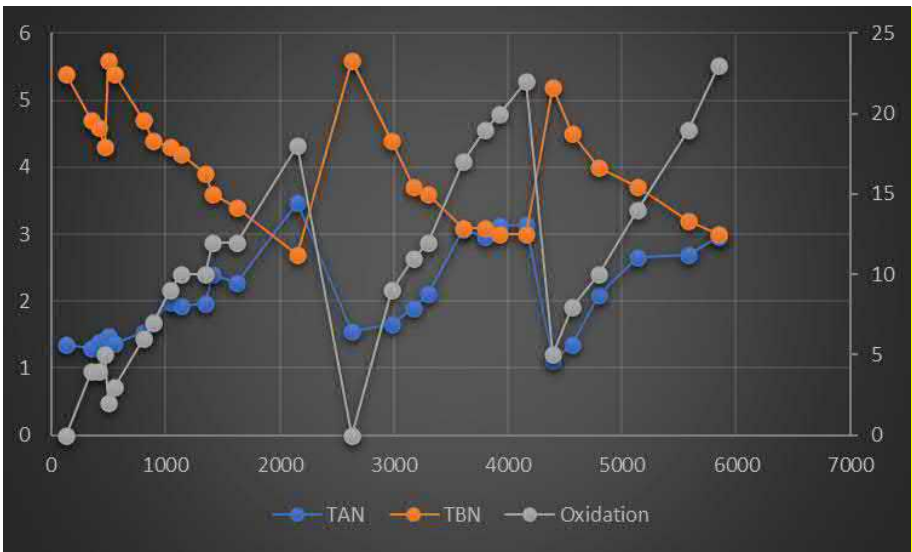
The first oil drain was completed at 479 hours which removed the initial copper levels expected with a new oil cooler. The second oil charge achieved 2,141 hours with only TAN and TBN showing caution. The third change was initiated at 1,698 hours by an alert for oxidation at 22, though TAN and TBN had hardly changed from the previous result and were normal. The last available sample is caution for TAN and TBN as well as alert for oxidation. It should be noted that when this oil was changed, around late March 2023, the oxidation figure was 5 at 78 hours oil life, suggesting that a significant amount of oil from the previous charge remained. However, the TAN and TBN data do not reflect this, they are very good. Thus, it is suspected that the oxidation figures may be unreliable and should be clarified with the lab. An updated reference sample is likely to be needed.

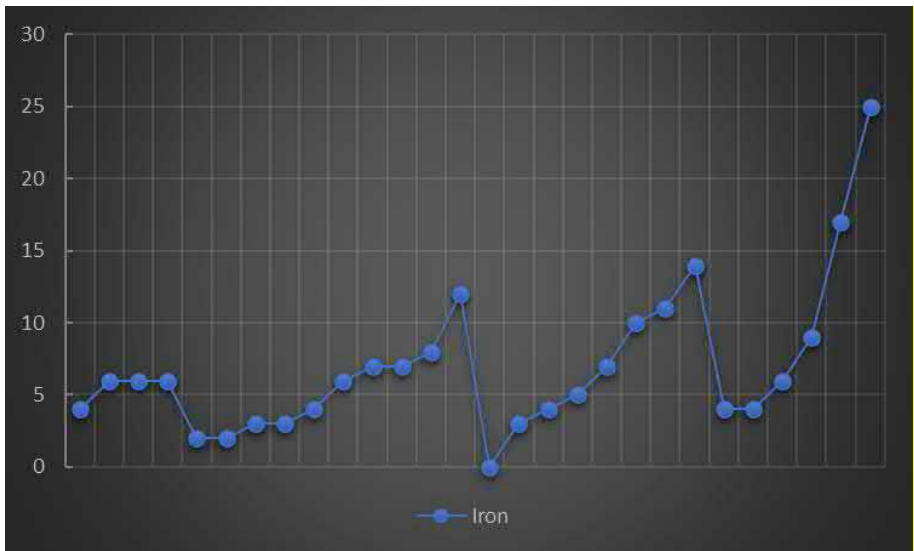
Wear metals are all consistently very low with the exception of iron which gradually increases over the life of the oil charge, as normal wear occurs to the liner. The last two samples show an increase in the rate of wear possibly associated with more frequent stop / starts on the engine, which is inferred from the UOA data in the sample dates and the recorded number of engine starts. Most recently the number appears to have increased from around 2.6 to 3.9 per day. There is no evidence of piston ring wear as chromium is consistently not seen.
