Borescope Inspection Report

Engine ID: #1

Engine Model: MTU 20V4000 L64

Inspection date: 7 November 2023

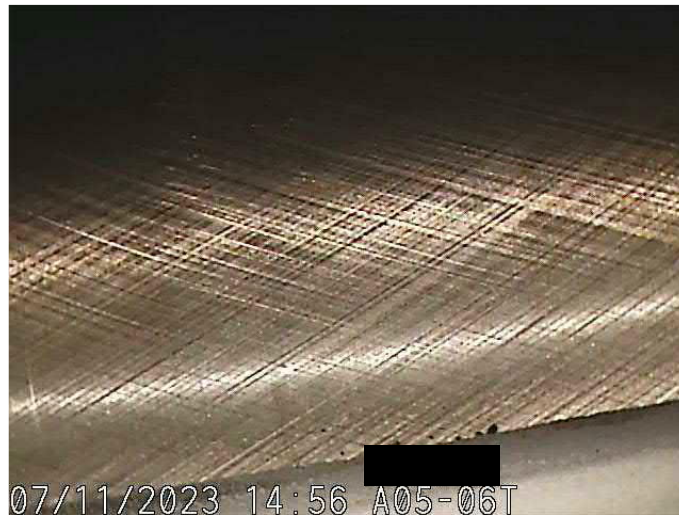
Occasionally a picture may be labelled incorrectly, as shown below. The picture is annotated as 06T whereas it is obviously the bottom and the file name has been recorded correctly, A05-06B.

The file name should be correct and overrides the picture annotation.
